# For the lessons to be learned from the Past Disasters ~Based on the Study Tours to the Sanriku Area affected by the Great East Japan Earthquakes of 3.11~

Teiichi Aoyama<sup>1</sup>, Komichi Ikeda<sup>2</sup> and Atsushi Takatori<sup>2\*</sup>

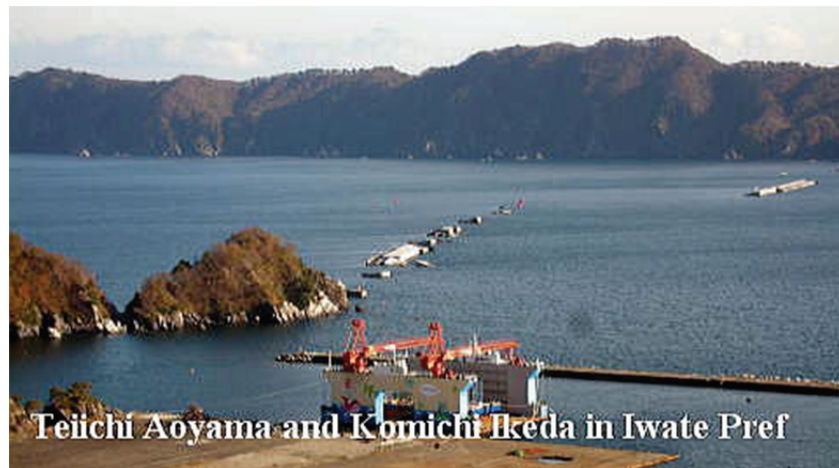
**Fig.5.** The breakwater at the entrance of Kamaishi bay destroyed by the tsunami  
(Construction cost: 120 billion yen)

The fifth lessons from our inspection of the suffering sites is that large scale breakwaters and tide embankments made of steel and concrete could not prevent damage caused by the tsunami. Although some of them may have weakened the damage or delay the tsunami attack arrival, according to the interviews to the victims we conducted in person, in many cases the existence of large breakwaters and tide embankments made them feel safe and turned out to have delayed their evacuation.

The lesson from the “3.11” disaster is that even huge and costly breakwaters and tide embankments cannot prevent tsunami damages. Land-use control and community planning which urges the residential area move from low-level ground near coast-line to high ground area is more essentially important measure than fighting natural disasters with steel and concrete.

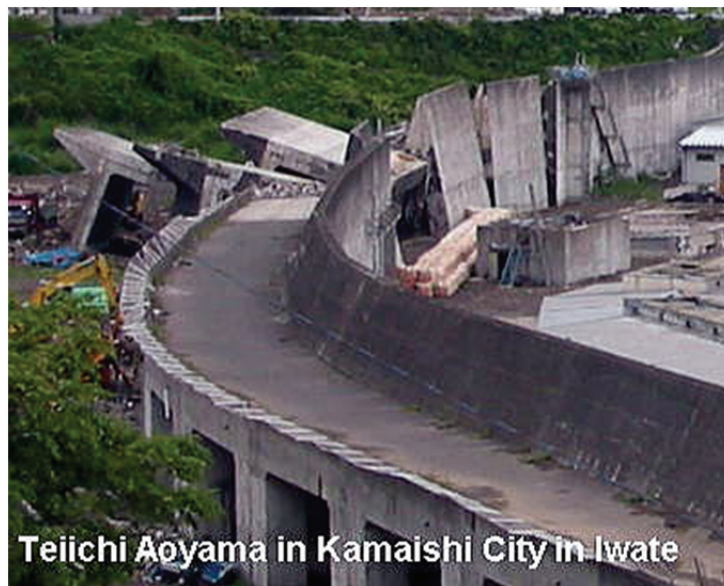
**Fig.6.** The tide embankment at Kojirahama fishing port in Touni Town, Kamaishi city,  
destroyed by the tsunami
